River Resource Center of Musconetcong Watershed Association

Location of Project: Asbury, NJ
Owner: Musconetcong Watershed Association
Submitted by: Mike Cronicz

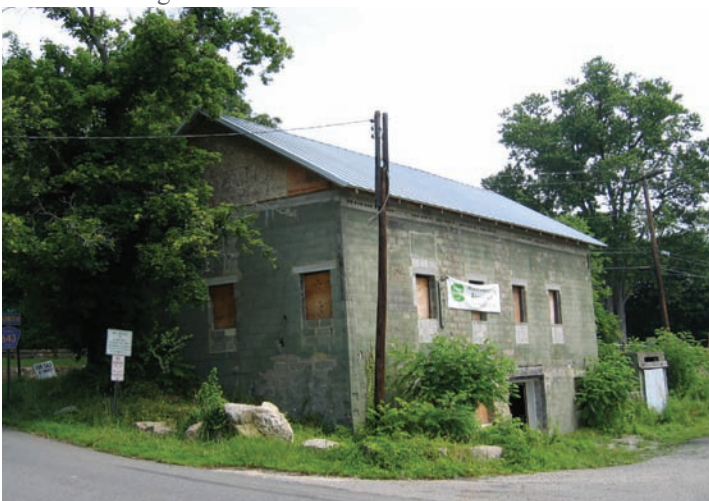
Before Renovation

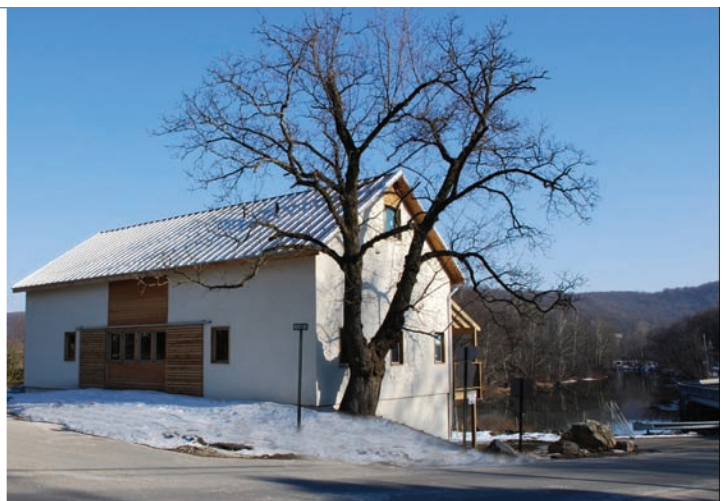
After Renovation
